# **Leon County Lakes Ecology**

## **Bradford Brooks Chain of Lakes**

McGlynn Labs Inc.

### 5.3.1: Bradford Brooks Chain of Lakes

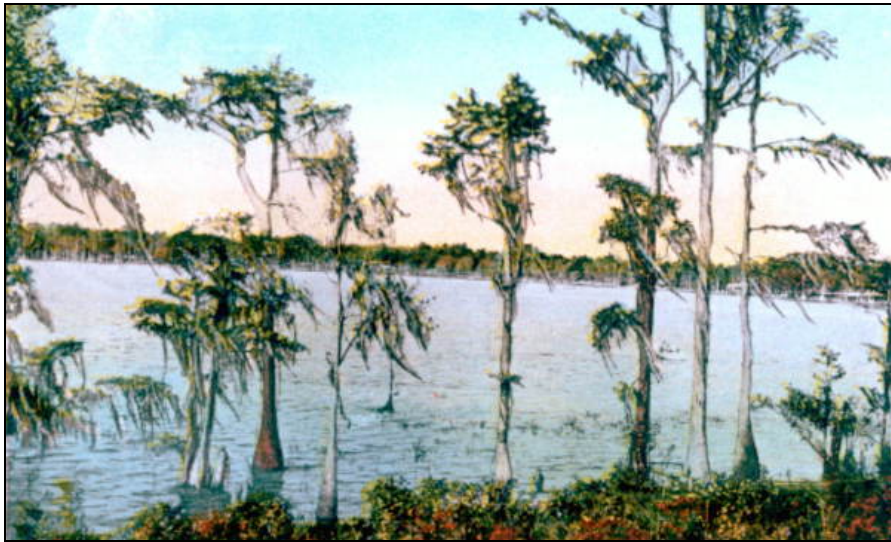
**Figure 5.3.1..6:** A postcard from the 1930s depicting Lake Bradford. It has not changed much.

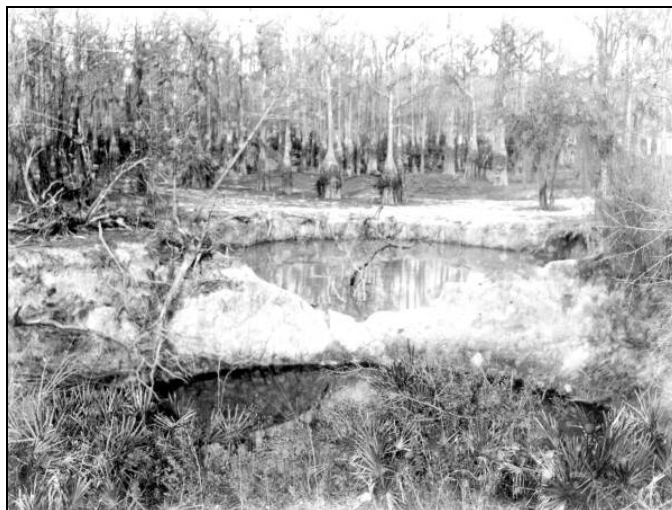
**Figure 5.3.1..7:** Two sinkholes in Lake Cascade (1932).

Lake Cascade has an active group of sinkholes, and has drained many times. In recent years Lake Cascade has emptied and refilled in 1990, 1992, 1999, 2000 and 2001. The twin sinks in Lake Cascade look much the same today as they did at the turn of the century. Lakes Bradford and Hiawatha have had active sinks in the past, but they were inactive during the drought of 1999. The Lake Bradford sink was active in 1956 when it drained the lake, and the fish population became stranded in the sinkhole. Local officials killed the fish with rotenone, (a toxin harmless to humans) so that they could be collected for food.

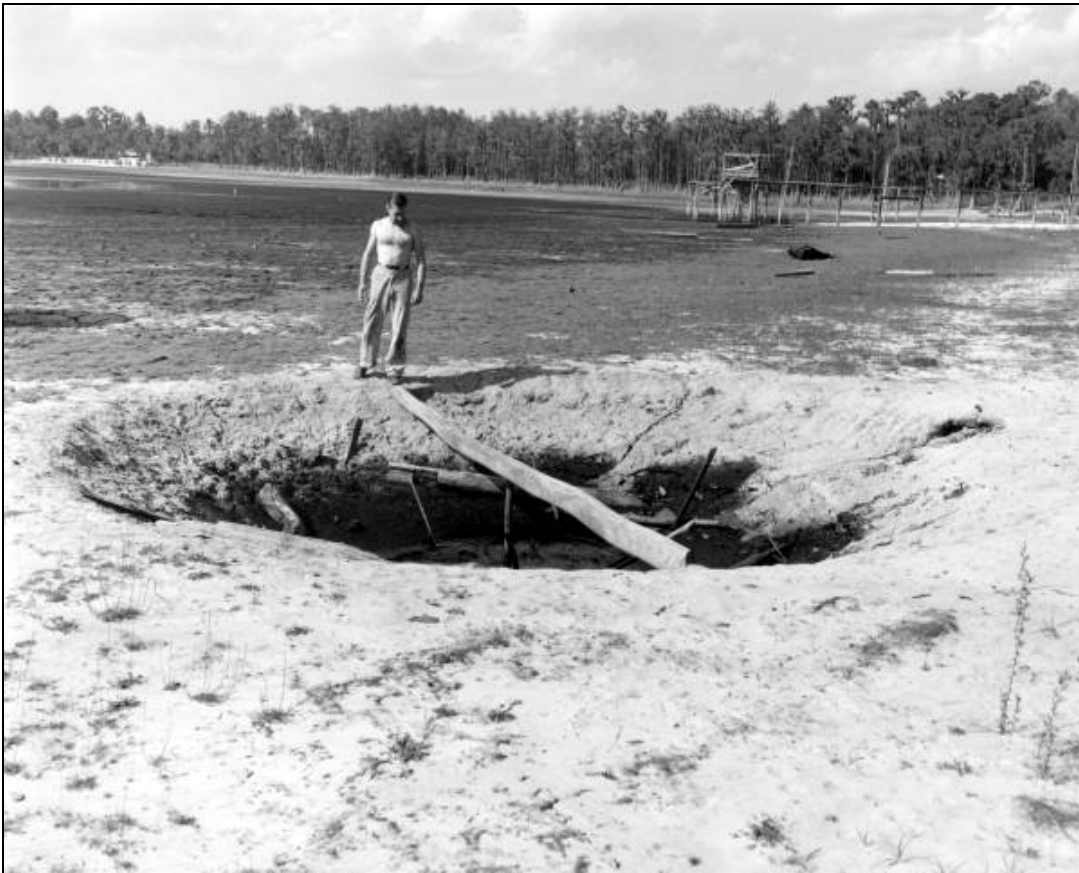
**Figure 5.3.1..8:** Sinkhole in dry Lake Bradford photographed in 1955 by Red Kerce.

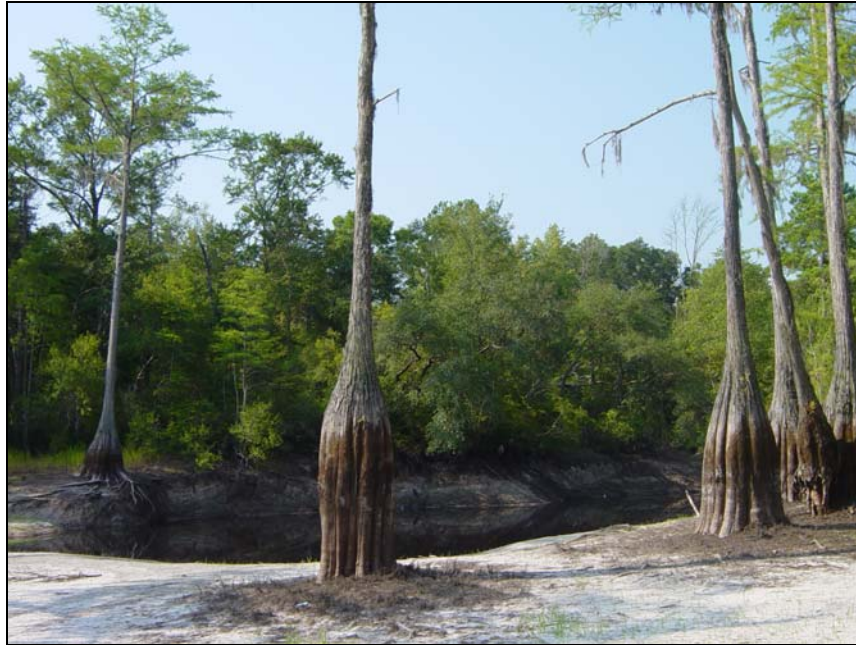
**Figure 5.3.1.9:** The two sinkholes in Lake Cascade (July, 2006).

In July 2006 The Bradford Brooks Chain of Lakes went dry again. It had been full for several years, unlike Lake Jackson did not refill completely since 1999. The sinkhole which drains the lakes is in Lake Cascade which is also the source of clean water to the lakes from the Bradford Brook. The only connection from Lake Cascade to the rest of the chain is through a small box culvert. This slough system needs to be protected.

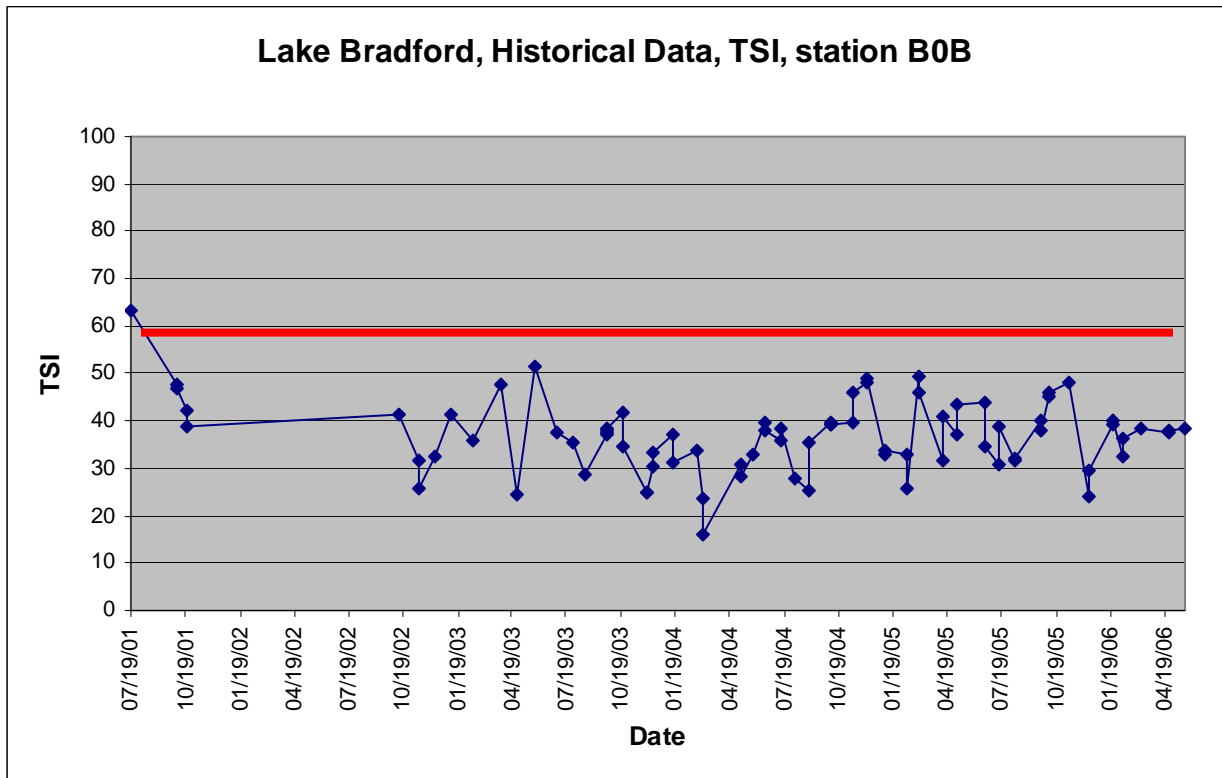
**Figure 5.3.11:** Bradford Brooks Chain of Lakes, Lake Bradford, Station B0B

**Bradford Brooks Chain of Lakes,  
Lake Bradford,  
Station B0B,**

Tannic lake,

According to FDEP criteria this lake would be impaired at TSIs greater than 60 units,

**\*Result: not impaired and holding steady.**

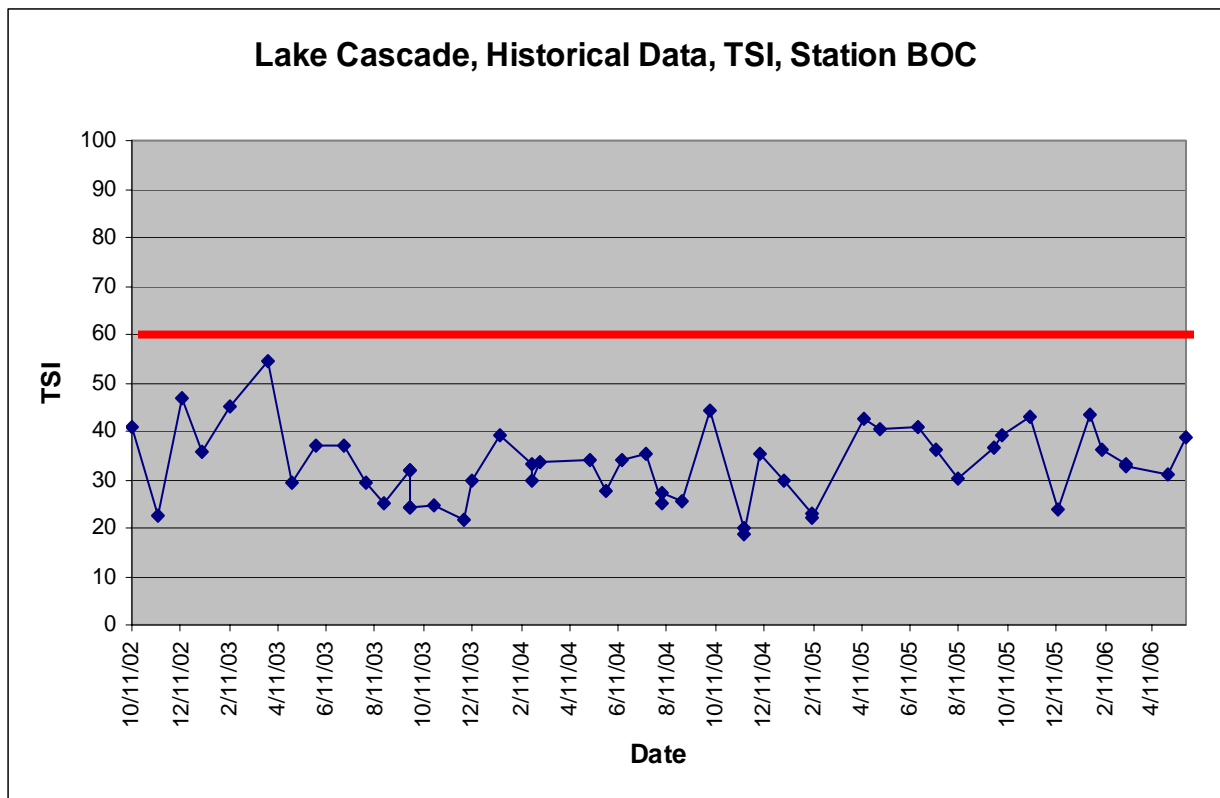
**Figure 5.3.1.12: Bradford Brooks Chain of Lakes,  
Lake Cascade,  
Station B0C,**

Tannic lake,

According to FDEP criteria this lake would be impaired at TSIs greater than 60 units,  
Data source LCL Data (McGlynn Laboratories Inc).

**\*Result: not impaired and holding steady.**

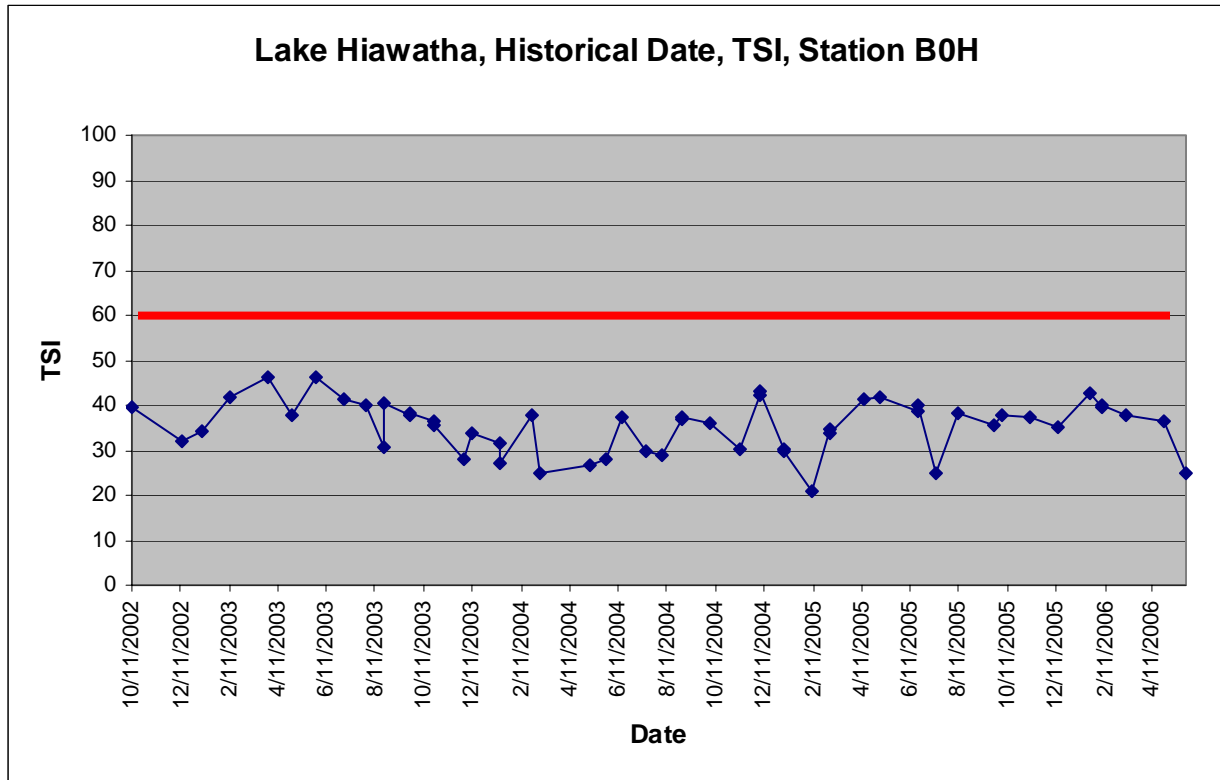
**Figure 5.3.1.13: Bradford Brooks Chain of Lakes,  
Lake Hiawatha,  
Station B0H,**

Tannic lake,

According to FDEP criteria this lake would be impaired at TSIs greater than 60 units,  
Data source LCL Data (McGlynn Laboratories Inc).

**\* Result: not impaired and holding steady possibly improving.**
