Leon County Lakes Ecology

Lake Hall

SECTION 4.4.2: Lake Hall

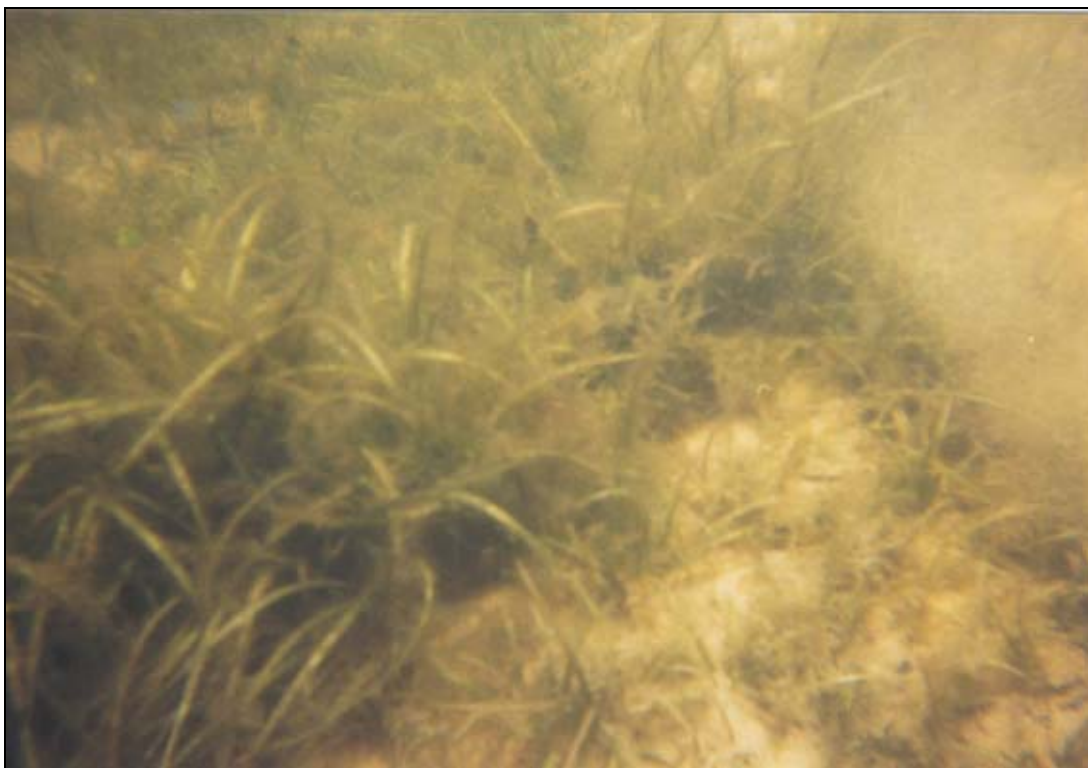
Figure 4.4.2.4: Native beds of beneficial aquatic vegetation can still be found in the shallows of Lake Hall. These plants are rapidly disappearing elsewhere in north Florida.

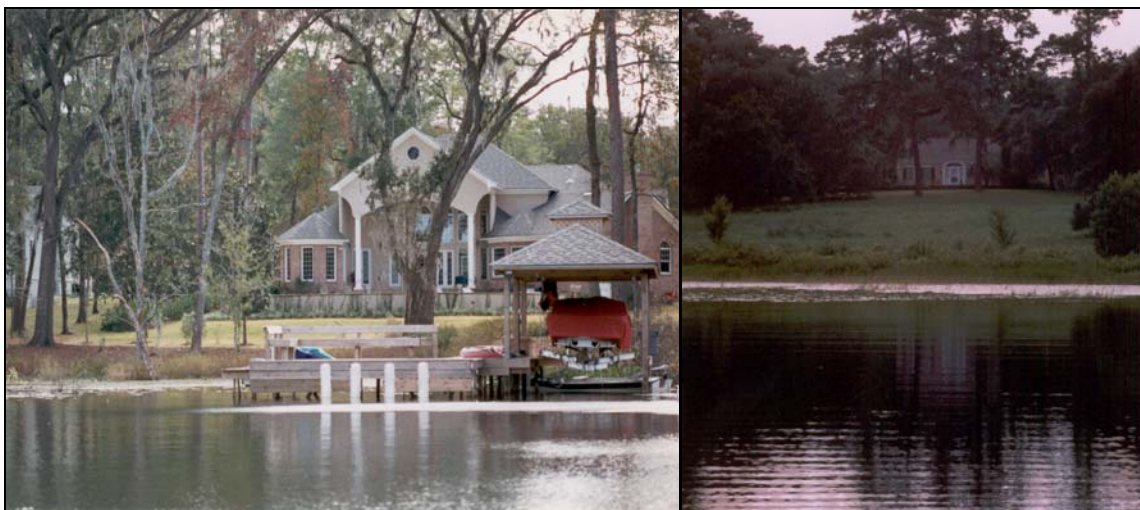
Figure 4.4.2.5: Leon County Lake stations in Lake Hall, H06 and H01 (1999). The first picture is from the eastern end of Lake Hall near Thomasville Road (station H06). Drainages from Thomasville Road were retrofitted during road widening. A karst depression between Thomasville Road and Lake Hall was also retrofitted to treat the stormwater. Previously the runoff into the Lake was untreated. Conditions have been improving at this station. The second picture is from the western side of Lake Hall (station H01) near the Alfred B. McClay House.

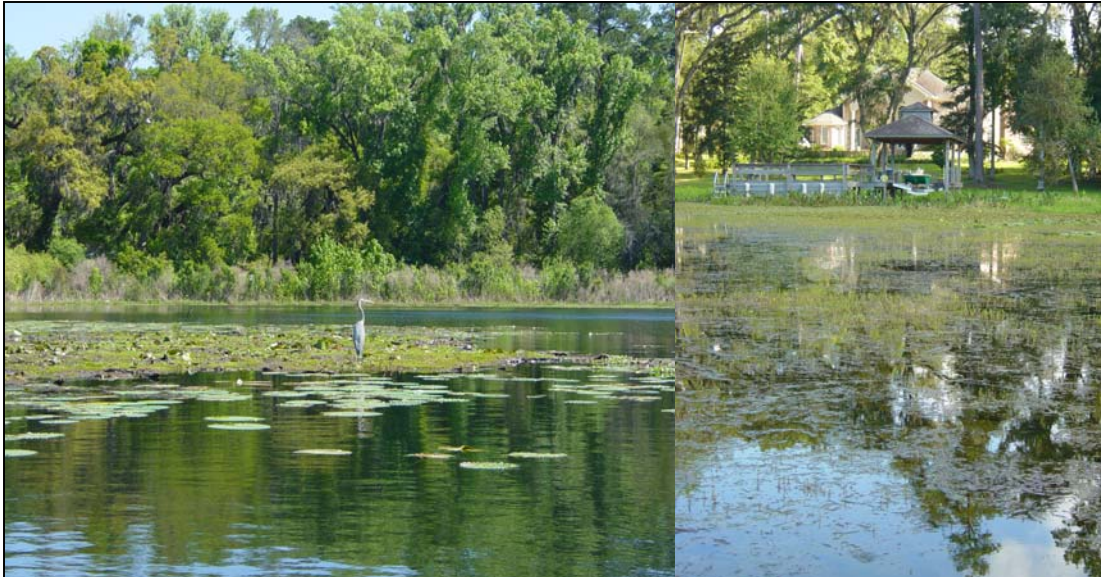
Figure 4.4.2.6: These are views from station H06 taken in October 2003. The first picture is of a tussock, which developed where the Hydrilla was treated with herbicide. This floating island floats around the lake. Note the dramatic large mats of floating plant matter in the second picture (this is the same house and dock in the previous picture (taken in 1999). By November 2003 the water was clear again.

Occasional algal blooms are a natural occurrence in our subtropical Florida lakes, and persistent blooms indicate that there may be problems with the water quality. During the past 11 years Lake Hall has experienced four such ephemeral algal blooms, with the most recent being in September 2003. This algal bloom was isolated to the eastern lobe of Lake Hall near where the *Hydrilla verticillat* was observed. The type of algae was identified as a non-toxic species of green algae by FDEP. At the time of the bloom much aquatic vegetation was found floating in this area. Lake Hall rose 3 feet after the March rains of 2003, which finally brought lake levels to a full pool. The water level rise may have caused the die back of aquatic vegetation. With the rise in water levels, the light environment of these plants was lowered. As the plants died back they shed their leaves, which floated to the top of the water column. Persistent winds from the west concentrated most of this dead plant matter on the eastern shore of the lake. The floating mats of plants cut off the light to the submerged vegetation growing under them, causing these plants to die back too. By October 2003 this bloom had subsided and the floating vegetation was gone.

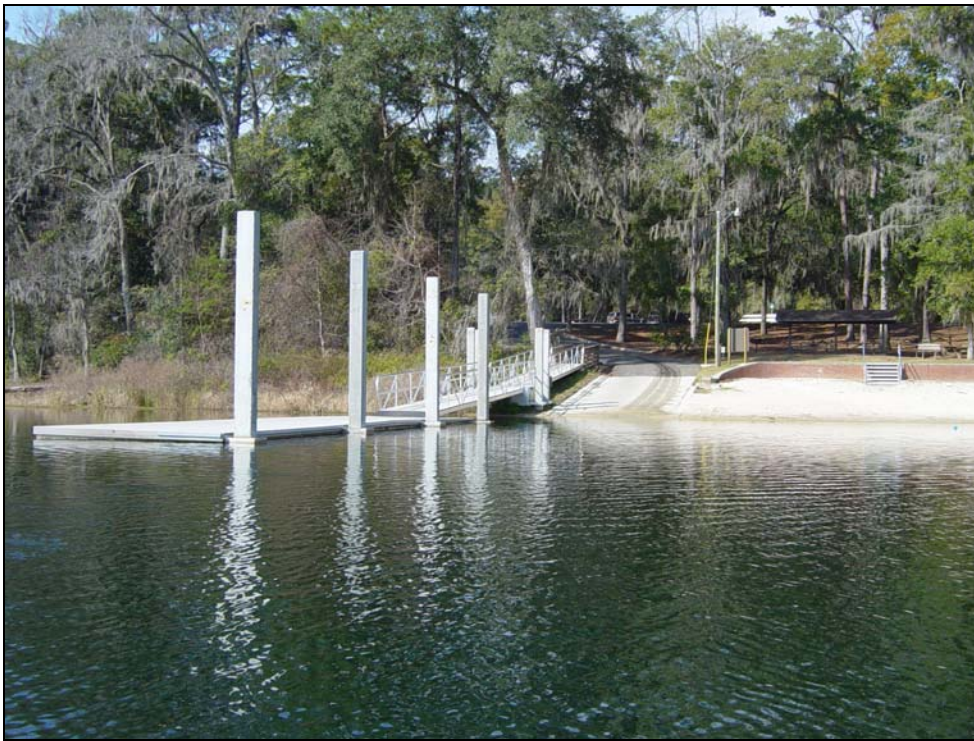
Figure 4.4.2.9: A pier was constructed adjacent to the swimming to diminish trampling of the littoral zone by boaters and the numerous crew teams utilizing Lake Hall.

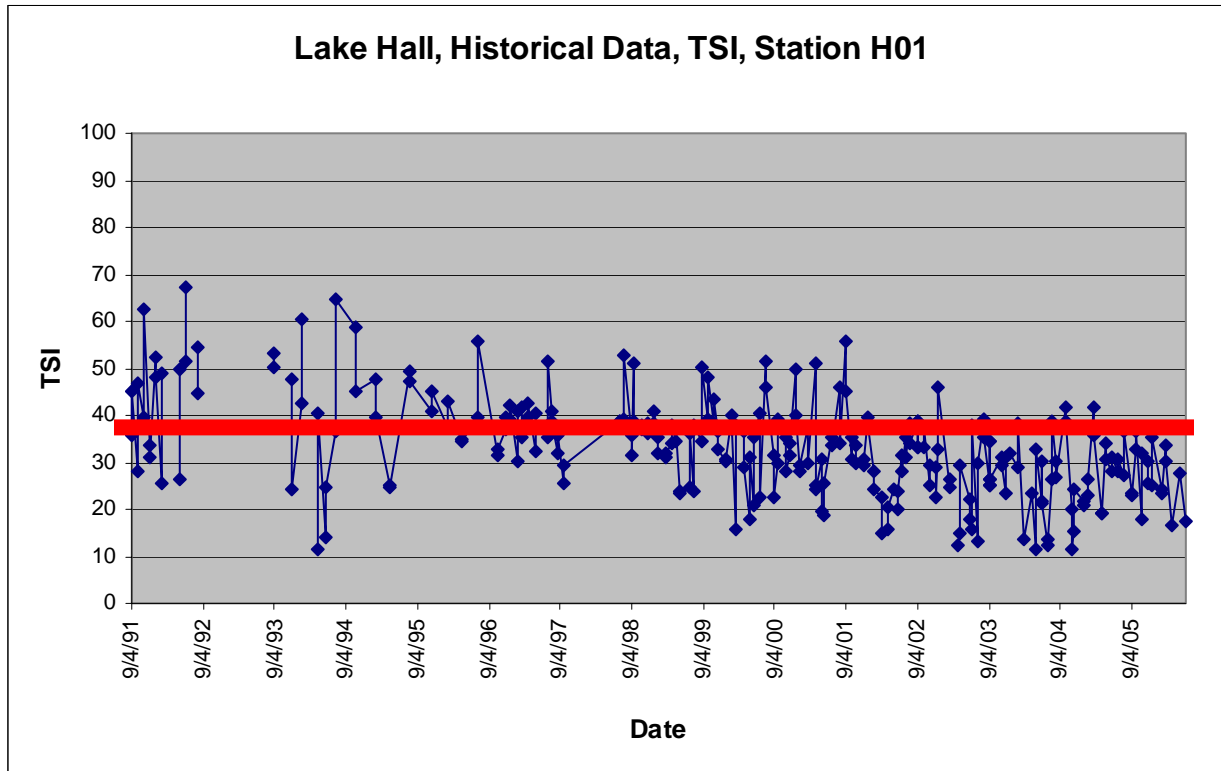
Figure 4.4.2.10: Lake Hall, Station H01, western side of lake

Clear lake,

According to FDEP criteria this lake would be impaired at TSIs greater than 40 units,
Data source LCL Data (McGlynn Laboratories Inc), data from before 1997 LCL Data
(CARRMa).

Data duration 09/91-09/04

*** Result: not impaired and improving.**

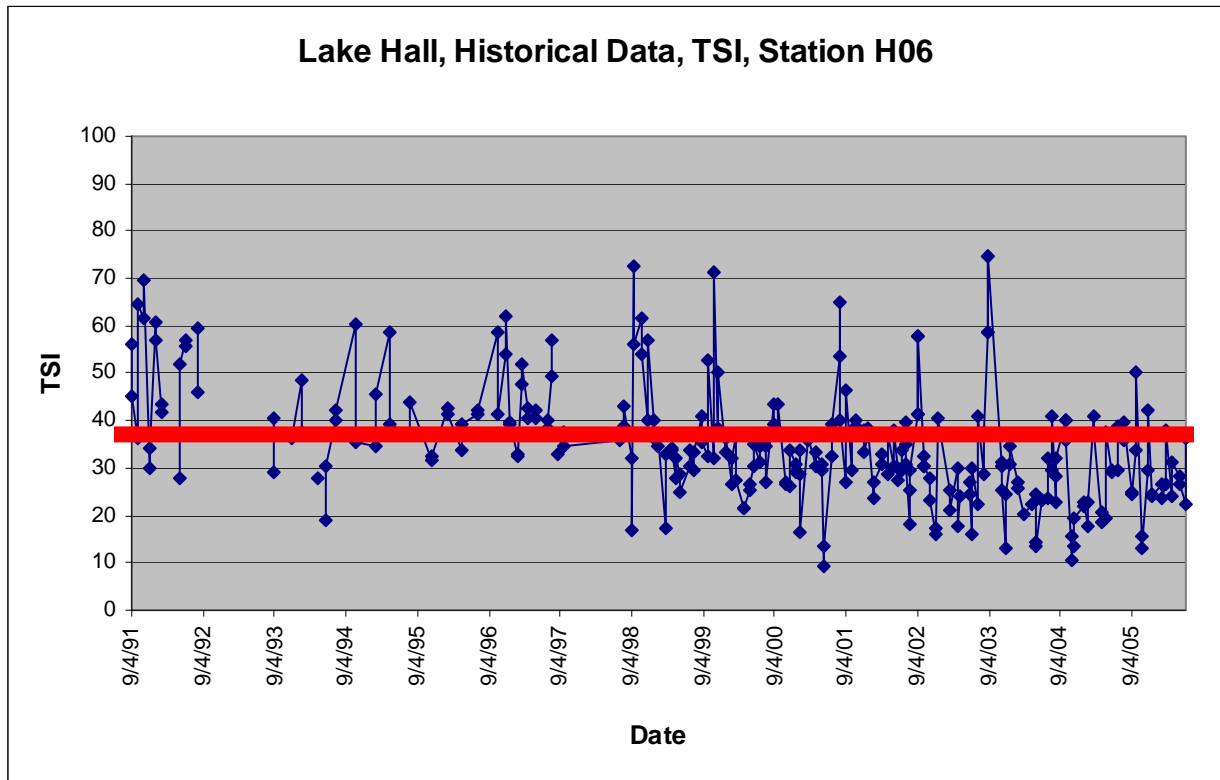
Figure 4.4.2.11: Lake Hall, Station H06, eastern side of lake Clear lake,
According to FDEP criteria this lake would be impaired at TSIs greater than 40 units,
Data source LCL Data (McGlynn Laboratories Inc) data from before 1997 LCL Data
(CARRMa).

Data duration: 09/91-09/04

*** Result: not impaired and improving.**
