Leon County Lakes Ecology

Lake Miccosukee

McGlynn Labs Inc.

5.2.1: Lake Miccosukee

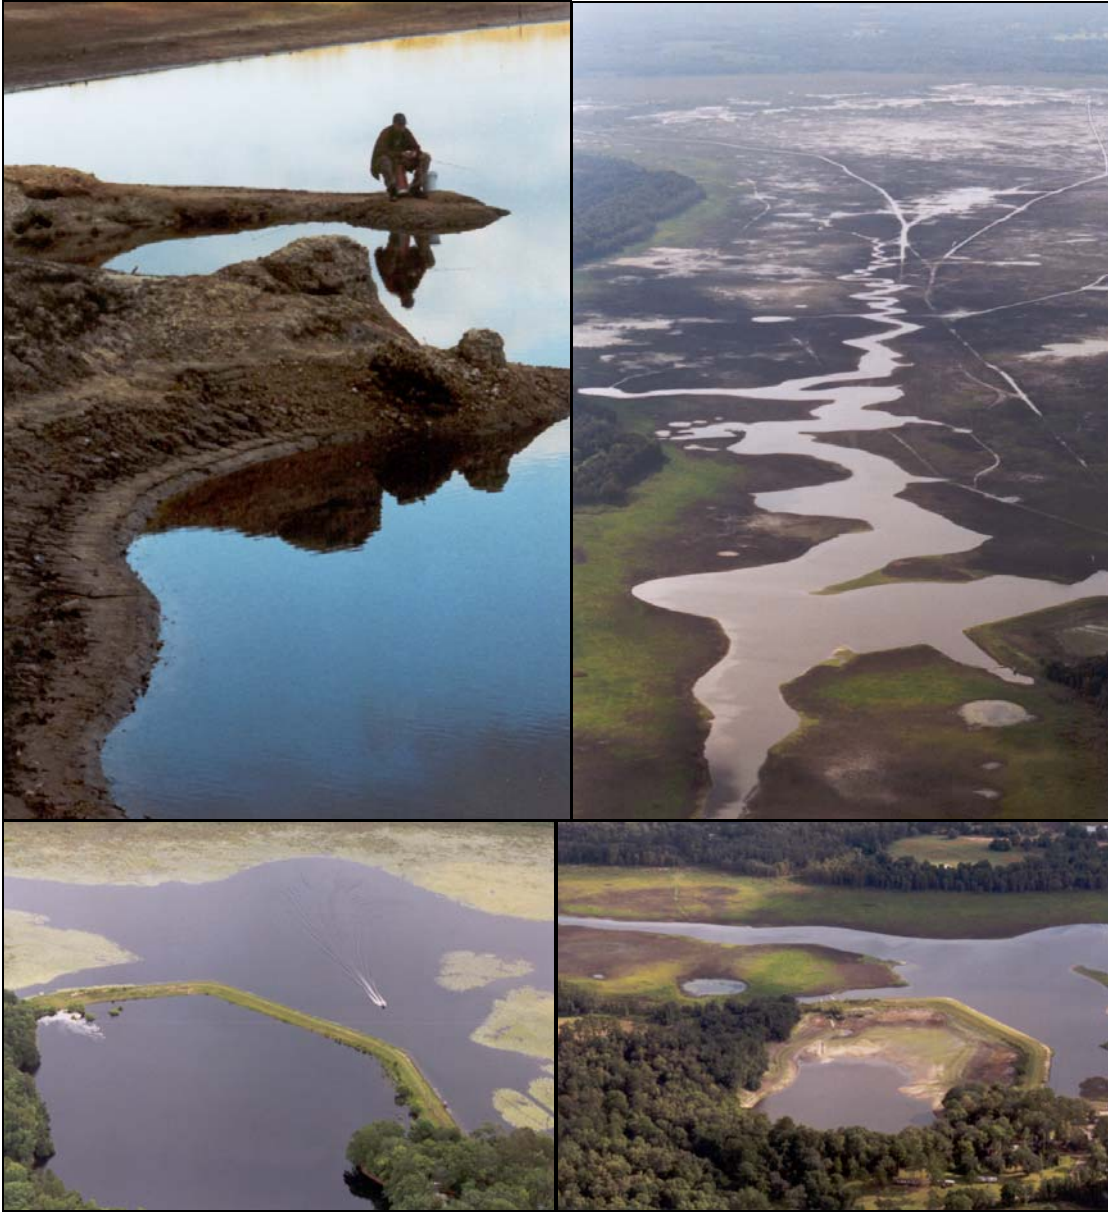
Figure 5.2.6: Drought of 1999 photos: Top left: Fishing in Miccosukee Sink; Top Right: the central valley, all that remained of lake Miccosukee during the drought; Bottom Right: The lake and sinkhole at full stage; Bottom Left: The lake and sinkhole at draw down

The gate in this structure was opened during the Drought of 1999. The lake was allowed to drain in a natural manner into Miccosukee Sink and the Floridan Aquifer like the other karst lakes of the region. The lake went dry except for its central valley, which was kept full of water to preserve the fish population. During the 1999 Dry Event we measured an acceptance rate of 60 cfs at the sinkhole, measured after a rainstorm partially filled the lake basin (April 2000). Michael Hill of the Florida Fish and Wildlife Conservation Commission closed and re-opened the control structure at Miccosukee Sink to give us a chance to measure the acceptance rate of the sink. At higher water levels, when there is greater head pressure the acceptance rate could be larger. The shallow bathymetry of Lake Miccosukee, coupled with the large acceptance rate of the sinkhole has caused the formation of a very pronounced ravine through the center of the lake. This underwater valley meanders for over 2 miles, with depths of over 14 feet.

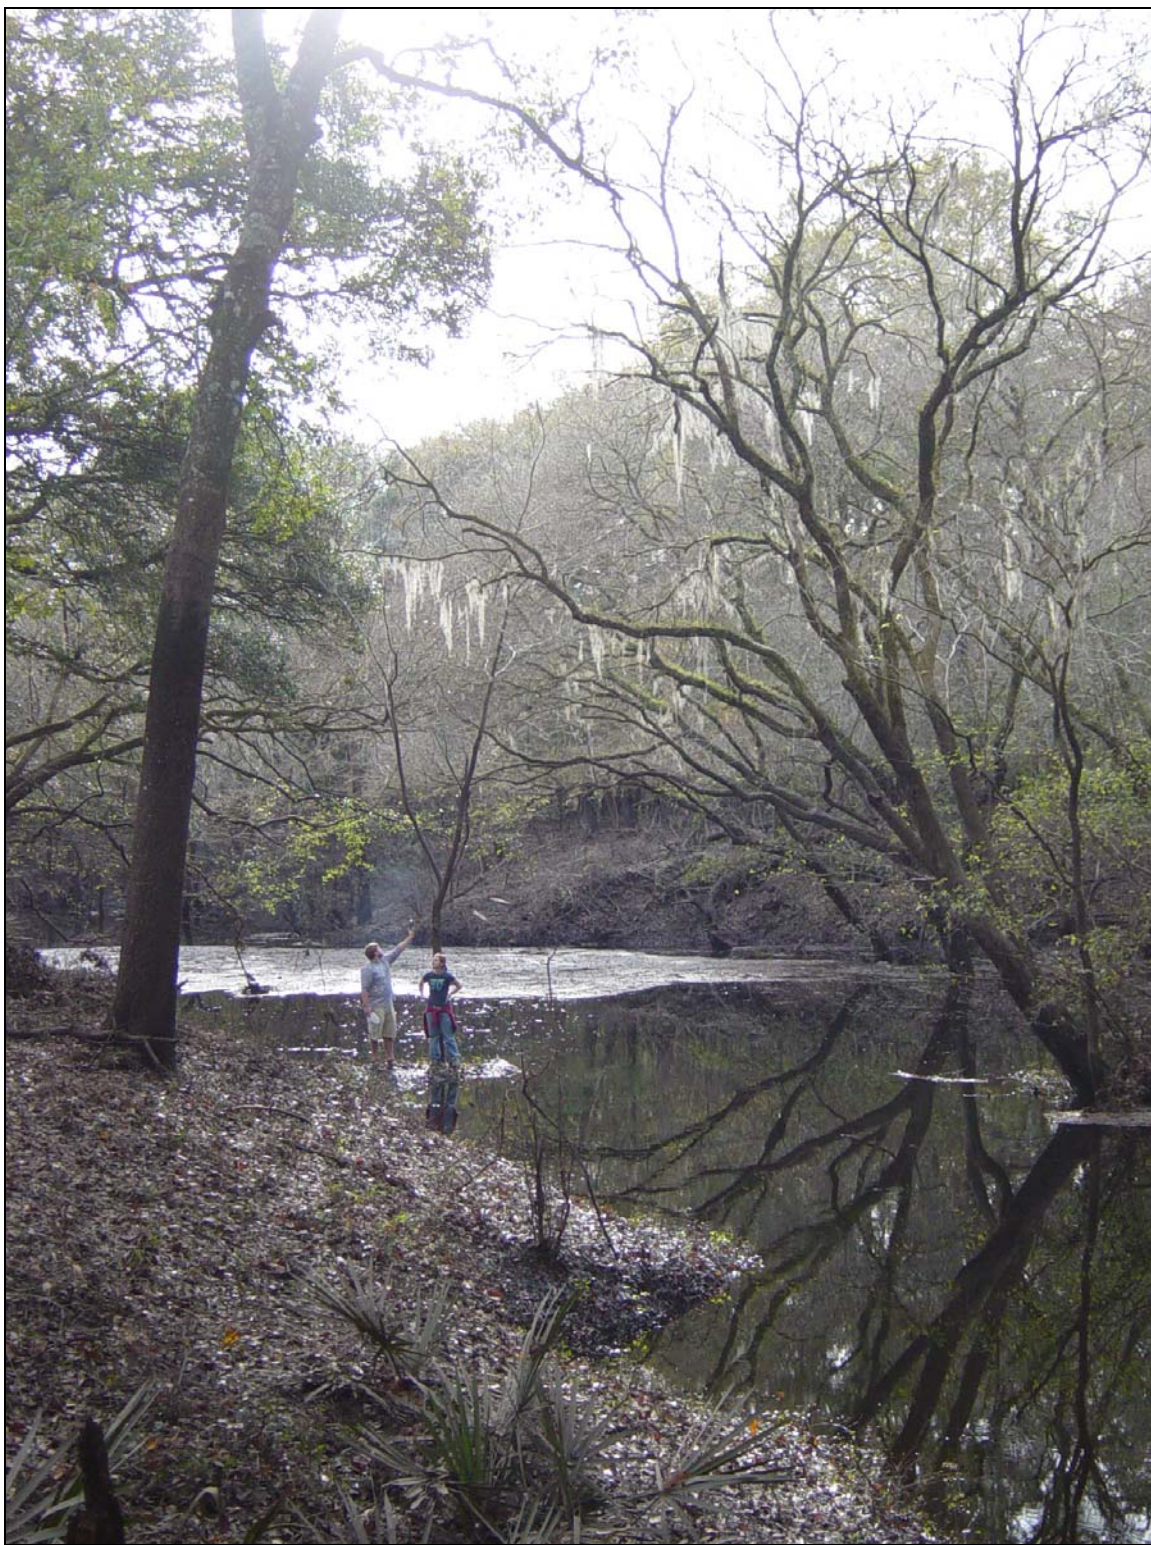
Figure 5.2.7: Lake Drain Sink on the southern side of Lake Miccosukee (12/04)

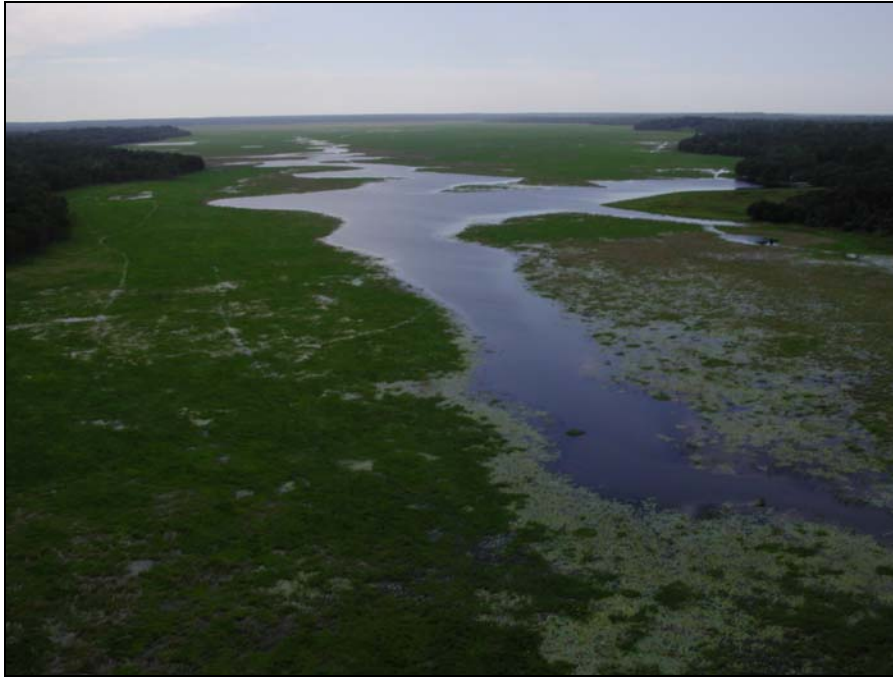
Figure 5.2.8: Looking up Lake Miccosukee, note the thick growth of Maidencane which currently obscures the water, which is 4 feet deep, on the average. (August 2001, photo by Michael Hill, GFC).

These superficial fires seemed to have promoted the growth of maidencane. The fires burned only the dry vegetation, which released the nutrients bound within the vegetative material and promoted seed bed germination. Maidencane, normally a beneficial aquatic grass, covered the lake bottom as a luxuriant mat of new growth. Perhaps in an earlier version of Lake Miccosukee, herbivores would have eaten this tender new growth. Instead, after the lake refilled, the maidencane rose thicker than before above the waters, giving Lake Miccosukee the appearance of dry land. A hotter fire burning down into the

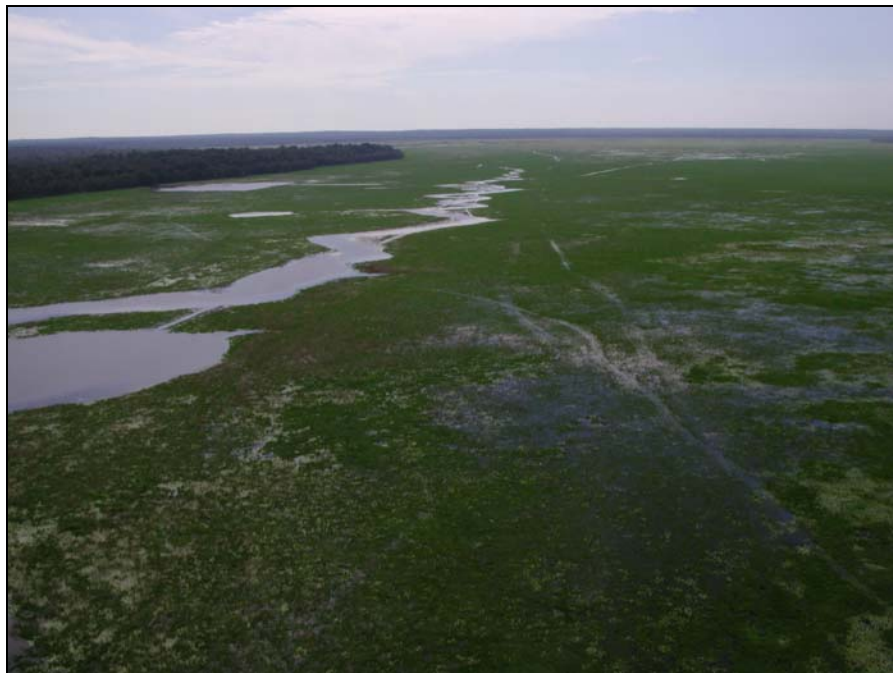
Figure 5.2.9: Looking down Lake Miccosukee, note the thick growth of Maidencane which currently obscures the water, which is 4 feet deep, on the average. (August 2001, photo by Michael Hill, GFC).

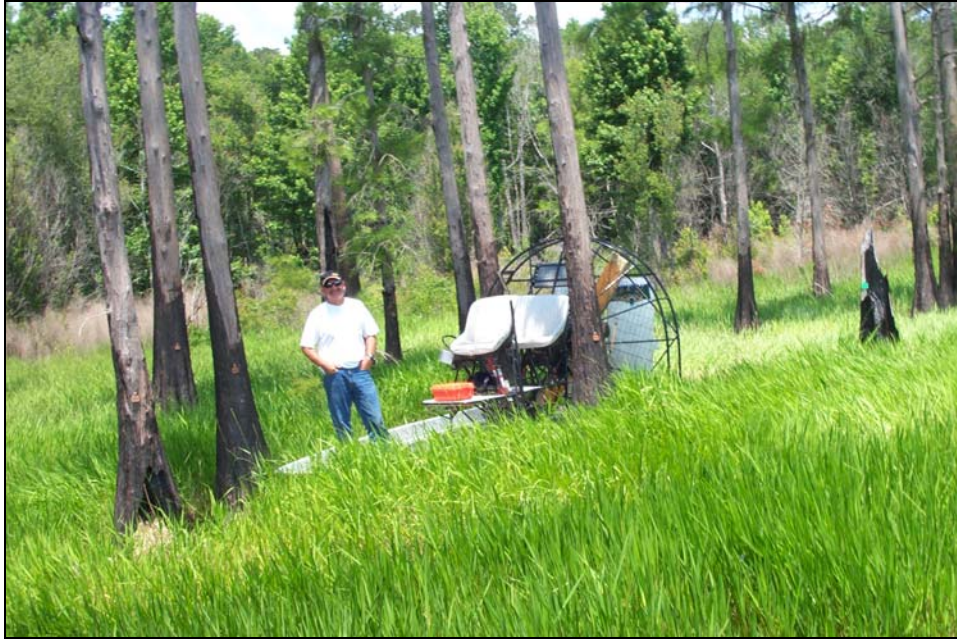
Figure 5.2.11: Lake Miccosukee with Jesse VanDyke and his airboat. This picture was taken after the controlled burn in May 2001. Note the thick growth of Maidencane and the basal burning on the cypress trees. Cypress proved to be less fire resistant than previously thought. Spanish moss on their branches acted as a fire ladder carrying the flames to the crown of the trees (photo by Michael Hill, GFC).

It soon became apparent during the burn that cypress trees are not very resistant to fire. The Spanish moss which hangs low on its branches tends to behave as a fire ladder, rapidly catching fire from the shorter grasses and conducting the flames to the crown of the tree where the entire tree became a torch. The bases of the trees continued to smoke and smolder for weeks. It was evident that even superficial fires can heavily damage cypress trees. Other lakes like Lower Lake Lafayette, where fire is totally suppressed, are filling with cypress and could benefit from even a minimal burn. However, Lake Miccosukee does not appear to have benefited from the recent controlled burnings.

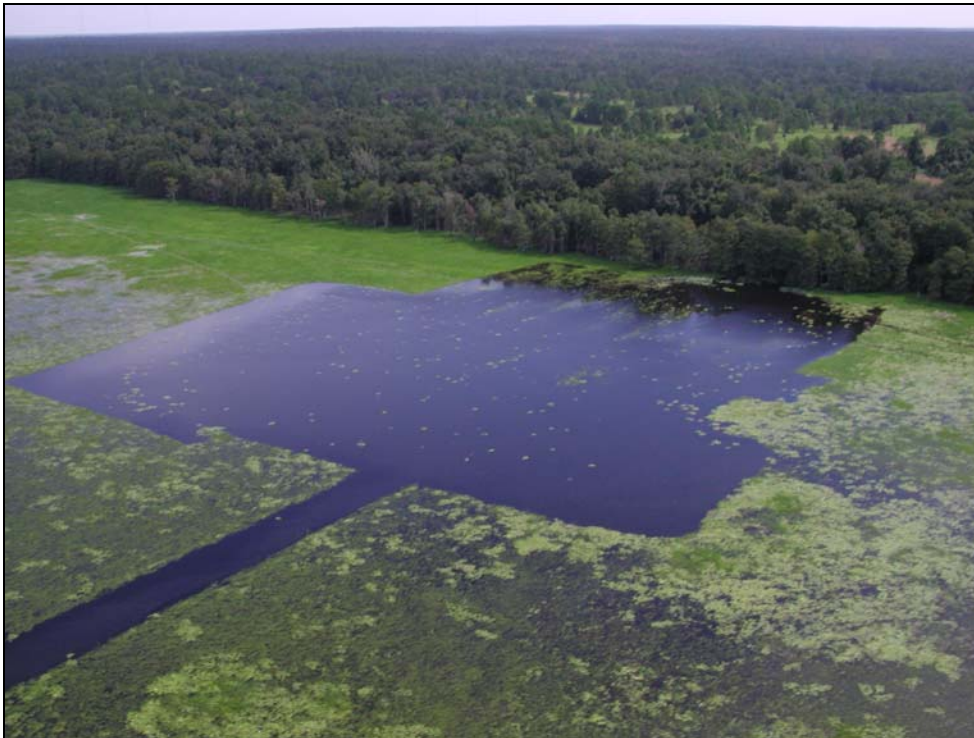
Figure 5.2.12: A part of lake Miccosukee where sediment was removed during the drought by the Florida Game and Fresh Water Fish Commission. These techniques were utilized during the drought to try to improve the lake by creating open water habitats (August 2001, photo by Michael Hill, GFC).

While the lake was dry several restoration methods were utilized. Several areas of the lake were scraped with mechanical devices and removed up to three feet of sediment and vegetation. Most of the lake bottom was also burned during the drawdown, which was accomplished with very superficial fires. These lake bottom fires had to be extinguished every evening. Permits could not be obtained from the Forestry Service to allow fires to burn into the muck deposits within the lake; although this would have created deep areas within the lake and future open water habitats. The Forestry Service did not want the smoke from the fires since it could have caused traffic accidents on Highway 90 to the south of Lake Miccosukee.

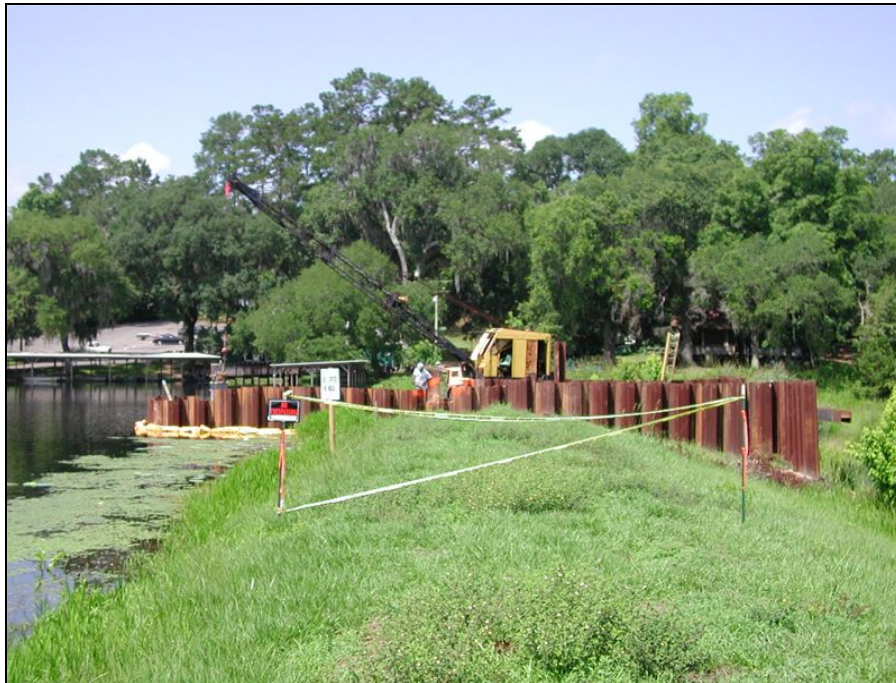
Figure 5.2.13: The northern dam on the sinkhole at lake Miccosukee failed. The old control structure rusted through and was replaced. The GFC repaired it. Lake water levels are normal (photo by Michael Hill, July 2004)

An earthen dike and a concrete spillway were built around the sinkhole at the northern end of the lake in 1954 to 'keep the water in'. A wooden weir was built at the southern end of the lake to keep the water from disappearing into Lloyd Sink. From 1954-1988 water levels were stabilized to such an extent that the bottom was exposed only twice, in 1977 and 1988 for a total of 6 months (Cooksey, 1989).
