Leon County Lakes Ecology

Lake Munson

McGlynn Labs Inc.

7.3.2: Lake Munson

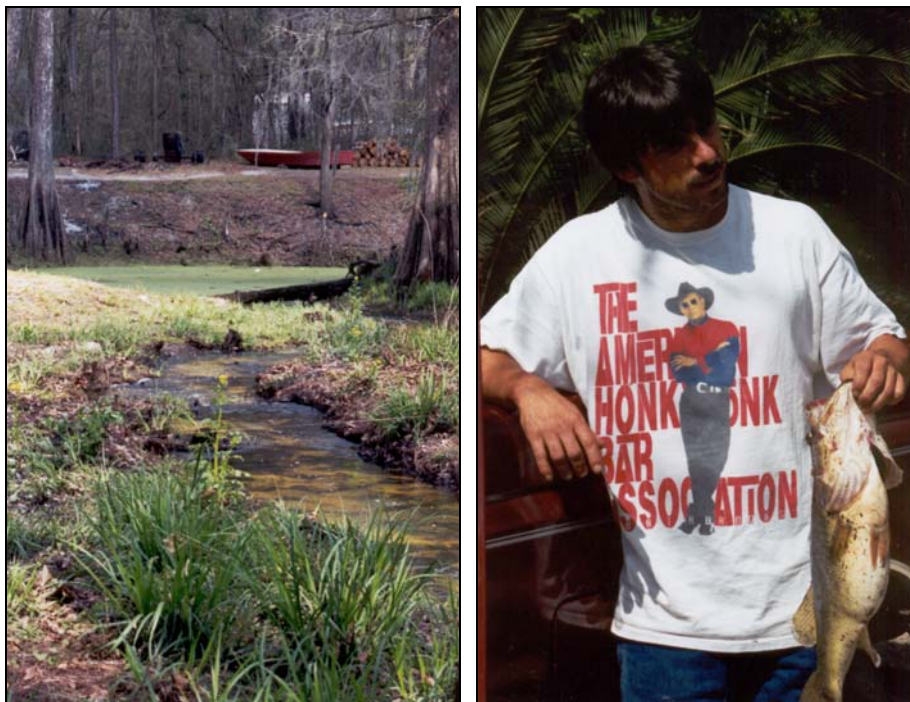
Figure 5.3.2.6: Ames Sink, approximately 5 miles north of Wakulla Springs, is where the outflow from Lake Munson goes underground. A Largemouth Bass (*Micropterus salmoides*) from Lake Munson.

The outflow from Lake Munson disappears into the aquifer through in a series of sinkholes. Urban stormwater flows into these sinkholes south of Lake Munson, flowing off from one to the other as they are overwhelmed by the flow of stormwater. Under most circumstances this water goes directly into the sinks, but during major floods events it breaches the sinks and fills low lying areas like the slough system, flooding many homes in the Woodville Recharge Basin. An effort is currently underway in Leon County to purchase this flood prone area.

Pond, which indicates that the sink was not open. On most occasions Aimes Sink swallows most of the outflow from Lake Munson.

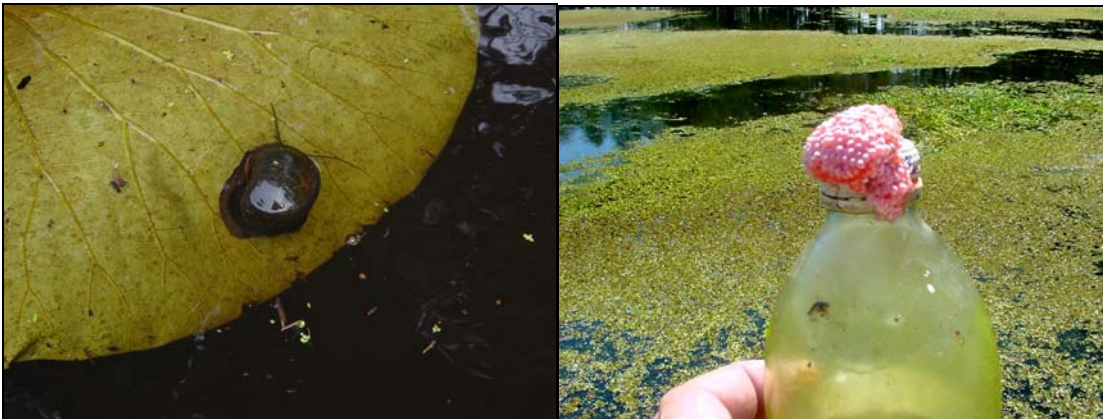
Figure 5.3.2.7: Invasive exotic Channeled Apple Snails, *Pomacea canaliculata*, have been found in Lake Munson. First picture depicts a snail on a lily the second pictures shows the characteristic pink egg clusters on a bottle floating in Lake Munson.

In late 2005 invasive exotic Channeled Apple Snails appear to have eaten most of the aquatic vegetation in Lake Munson. Before this it was almost impossible to get a boat through Lake Munson. Now it is easy to get a boat across Lake Munson but the water has had a persistent algal bloom since September 2005. This algal bloom is composed of *Microcystis*, a species of bluegreen algae that are known to produce algal toxins. These toxins are hepatotoxins, teratogens, neurotoxins and tumor promoters. Unfortunately these toxins are present in the waters of Lake Munson and have been detected at significant levels with the lake several times over the past year. Since the algal bloom has been persistent over that time the toxins have probably been there too. The water from Lake Munson flows into a sinkhole (Aimes Sink), which flows to Wakulla Springs in about a week's time.

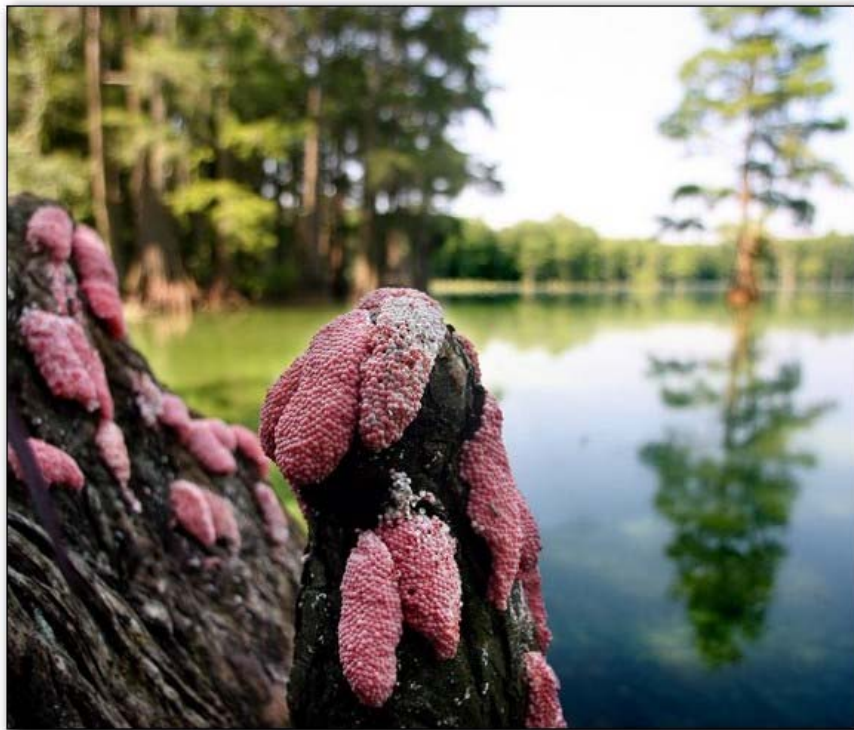
Figure 5.3.2.9: Invasive Exotic Channelled Apple Snail eggs on a cypress knee (photo by Mike Ewen, Tallahassee Democrat, 05/06)

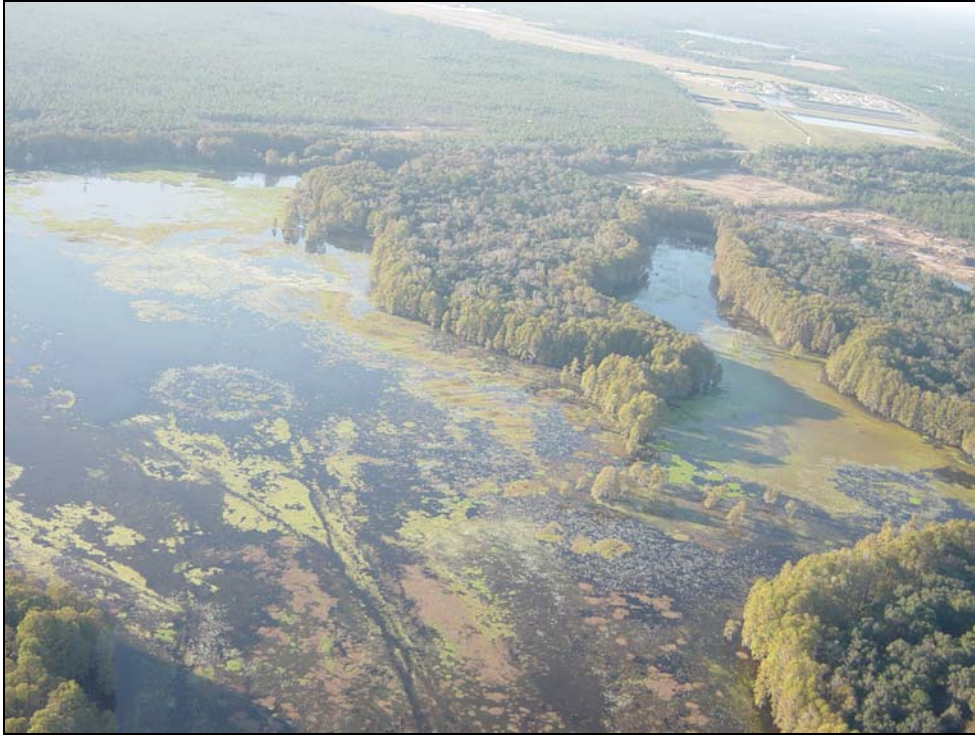
Figure 5.3.2.10: Aerial View of Lake Munson before the snails, looking north up Munson's Slough

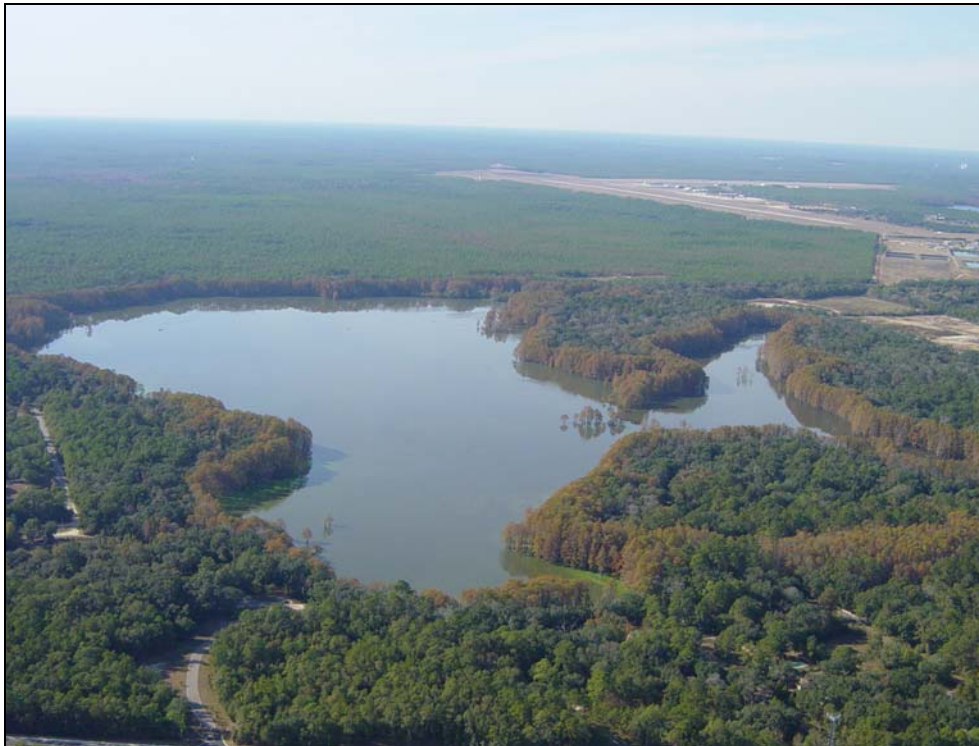
Figure 5.3.2.11: Aerial view of Lake Munson looking north, after the snails. Note the difference in the aquatic vegetation. The invasive exotic Snails have consumed most of the macrophytes, which have been replaced by a toxic algal bloom (see green algal scum in lower right corner of lake) 11/05.

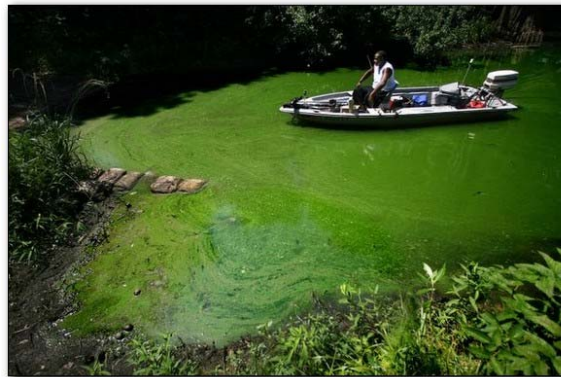
Figure 5.3.2.12: Lake Munson Algal Bloom at old boat ramp (photo by Mike Ewen, Tallahassee Democrat, 05/06).

Algal toxin analysis (Lake Munson) – The drinking water threshold effects level for the cyanobacterial toxin microcystin, as defined by the World Health Organization (WHO), is 1.0 µg/L MCLR. No other Algal toxin standard exists. Algal blooms were sampled in Lake Munson on 9/23/05 and 5/1/06 and they contained harmful algae and exceeded the WHO standard. Microcystis algae was found. Microcystin, an algal toxin, was assayed at 54.4 ug/L on 9/23/05 at and 26 ug/L on 5/1/06. There have been problems associated with incidental contact with water containing algal toxins and these blooms are properly termed Harmful Algal Blooms (HAB). The waters of Lakes Munson are connected to the aquifer by sinks and could potentially impact drinking water. The algal toxin analytical results from Green Water Labs and a poster from the Florida Department of Health are included (suggested for use in affected waters).

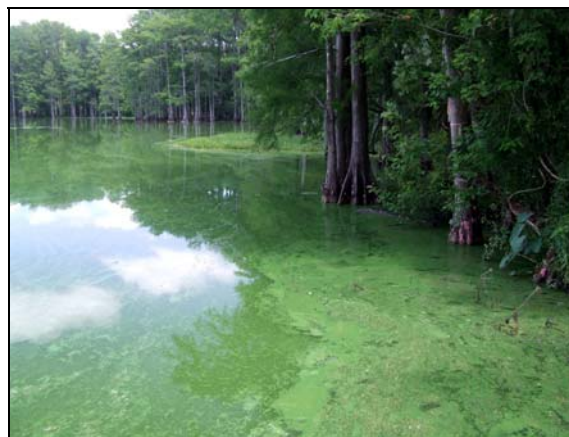
Figure 5.3.2.13: Lake Munson Algal Bloom at new boat ramp. Note the Channeled Apple Snail eggs on the cypress trees (photo by Michael Hill, FWC 05/06).

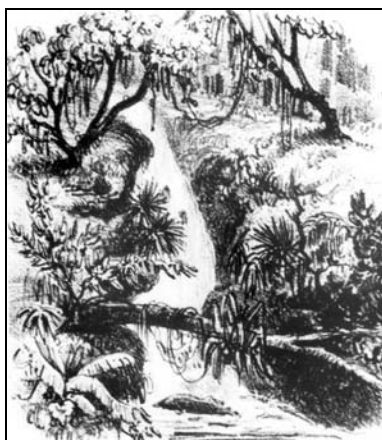
Figure 5.3.2A.1: An early drawing of the Cascade Sink and waterfall (~1820).

The Cascades Sink became a small lake and a popular swimming hole off the east side of South Monroe where the railroad overpass was constructed. It was even the site of a high diving competition, off the bluffs, and a suicide. Eventually as the little lake began to fill in with trash and sediment it became marshy and being near the railroad attracted vagrants. The City Dump and a Coal Tar Gasification Plant were located here. By 1959 the little lake was completely filled in (Lammers, 2000).

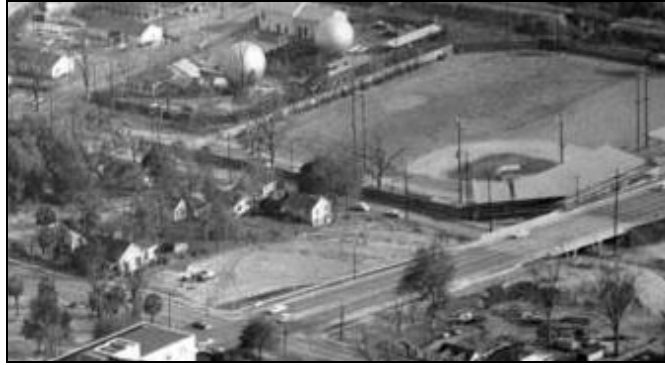
Figure 5.3.2A.3: The Coal Gasification Plant, seen here just behind Centennial Field in the early 1960's. The plant contaminated the soils at the site of the old Cascade Sink.

Once the Cascade Sink filled in the St. Augustine Branch began to flow on to Lake Munson since it no longer disappeared into the ground. Two sites on this watercourse were contaminated with toxics. The Coal Gasification Plant, on the site of the sink caused the soils to be contaminated with petroleum hydrocarbons like Polynuclear Aromatic Hydrocarbons. The site of the Elberta Crate Factory was contaminated with creosote. The St. Augustine Branch is now filled with urban storm water that flows into Lake Munson. Two holding ponds have been built to relieve flooding and water quality issues (Elberta Crate and Lake Henrietta). The excavation of the pond at Elberta Crate also removed the contaminated soils. Both these ponds had trouble with sinkholes opening in them. Elberta Crate Pond has had over 30 sinks open in it since it was built. A large sinkhole also opened in Lake Henrietta during construction in 2001.

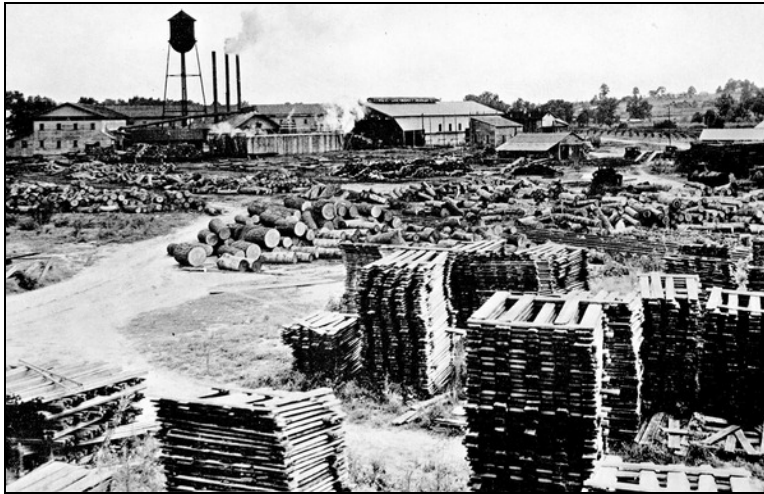
Figure 5.3.2A.4: Elberta Crate in the 1930's, where the soils were contaminated with creosote.

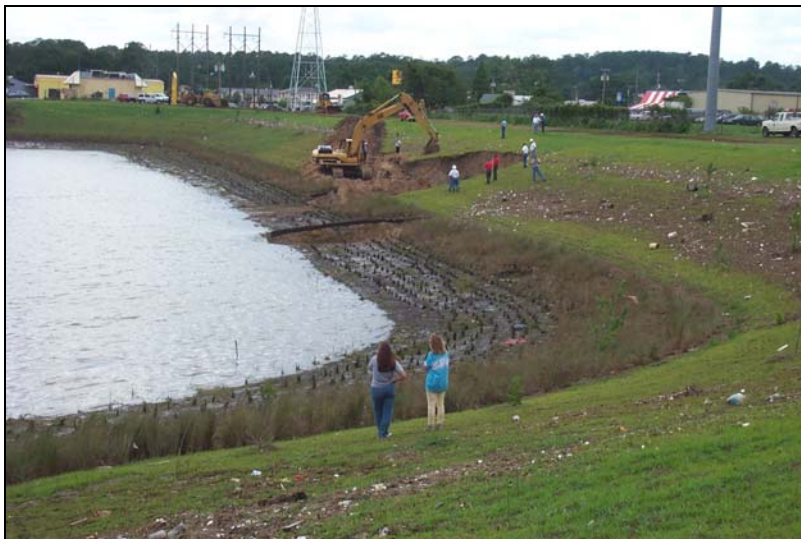
Figure 5.3.2A.5: Sinkholes in Elberta Crate Pond, 2002, when the contaminated soils were removed the resulting pond was developed over 30 sinkholes. These numerous sinks were filled with grout. Lime rock pinnacles weakened the clay liner. Similar conditions exist beneath the Civic Center and the Seminole Stadium. This implies caverns.

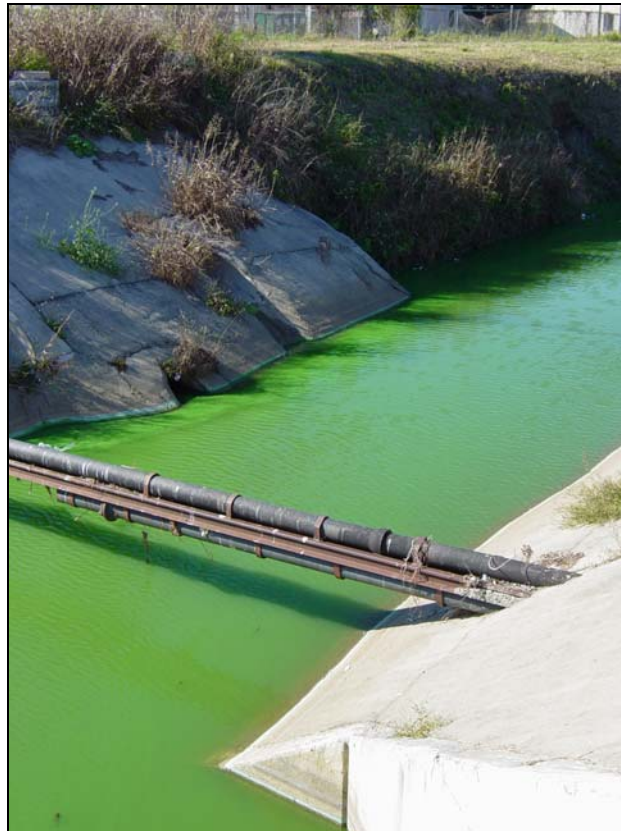
Figure 5.3.2A.6: The inflow to the Elbrta Crate Stormwater Pond. This water comes from a recently completed box culvert in which a creek (Budweiser Creek) that once flowed through the FSU campus was buried.

A chain of ponds is proposed in the Blueprint 2000 program for the old St. Augustine Branch starting at the site of the former Cascade Sink and extending between the FAMU and FSU campuses to the Alberta Crate Pond. The last segment (downstream near Springhill Road) has the greatest opportunity for treatment. The furthest upstream pond they proposed is a 50 foot deep pond at the site of the Cascade Sink. This will be constructed to remove soil contaminated by a coal tar gasification plant that once occupied the site. There is a high probability that sinkholes will form in this area. According to the project engineers there will be no water quality treatment upstream from the Cascade Pond. The water quality in this pond will be very bad unless a high maintenance treatment system is added. The problems with the drainage, most to the north of Tennessee Street need to be addressed or this project will be no more than a bandage, a temporary fix to a long standing problem in the heart of Tallahassee that needs to be addressed if future growth is anticipated. Burying the St. Augustine Branch, as planned in the downtown area, will remove all water quality considerations since the Branch will no longer exist as surface water and will be an underground pipe (box culvert). This is not a solution since it merely transports the stormwater water elsewhere.

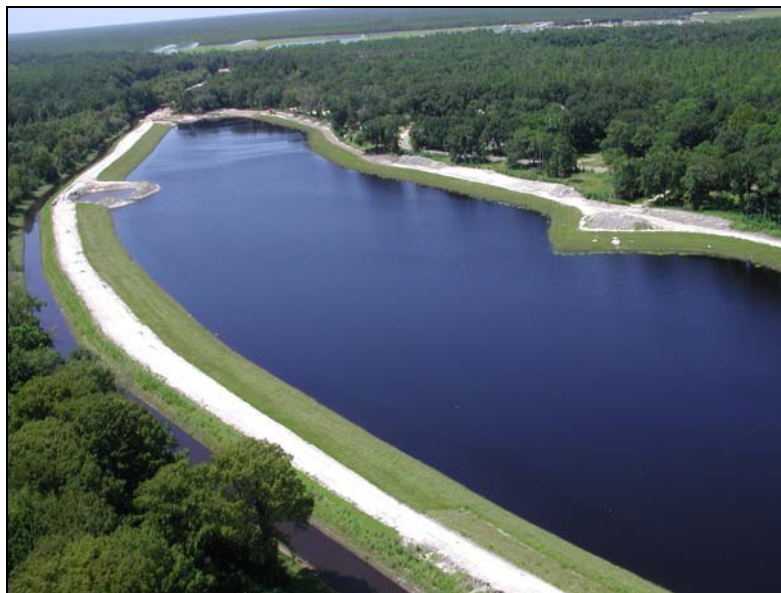
Figure 5.3.2A.7: The cypress trees in Lake Henrietta were cut down and it was modified into a stormwater facility. A large sinkhole that opened during construction is visible to the upper left
