Leon County Lakes Ecology

Lake Talquin

McGlynn Labs Inc.

4.2: Lake Talquin

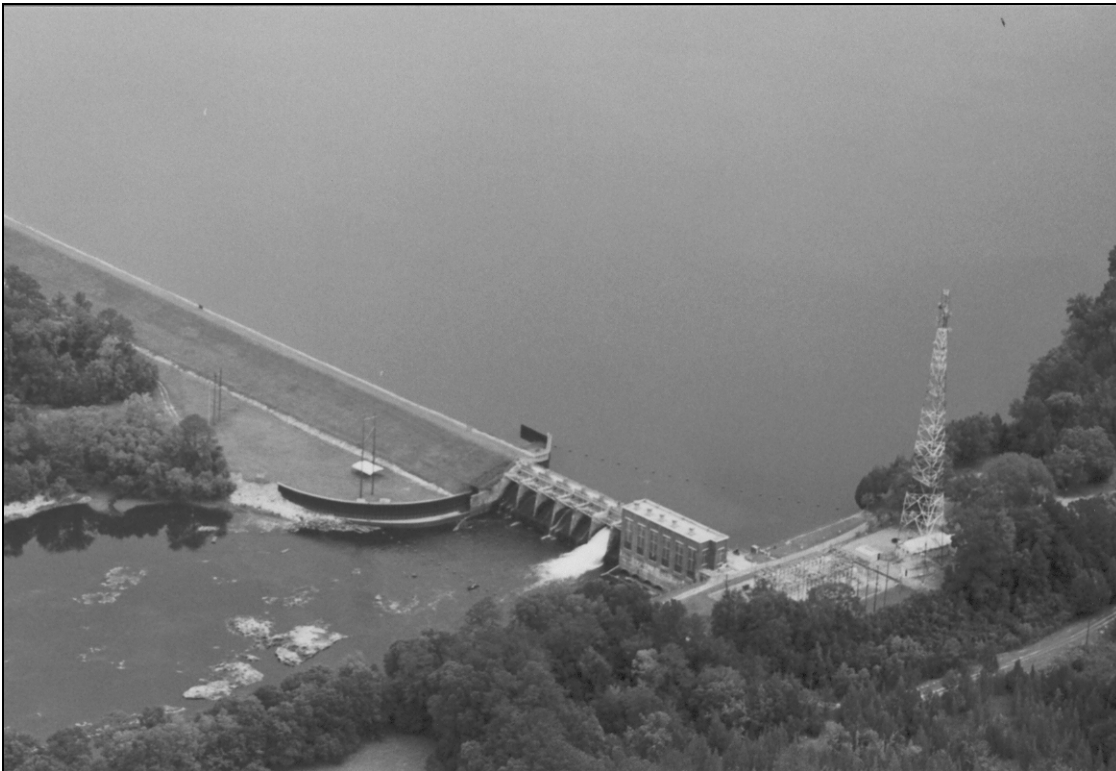
Figure 4.2.5: The Jackson Bluffs Hydroelectric Dam forms Lake Talquin by impounding the waters of the Ochlockonee River

Lake Talquin was created when the Jackson Bluffs Hydroelectric Dam was built across the Ochlockonee River (1928-1929). Lake Talquin's water quality is dependant on the water quality of the Ochlockonee River coming from Georgia.

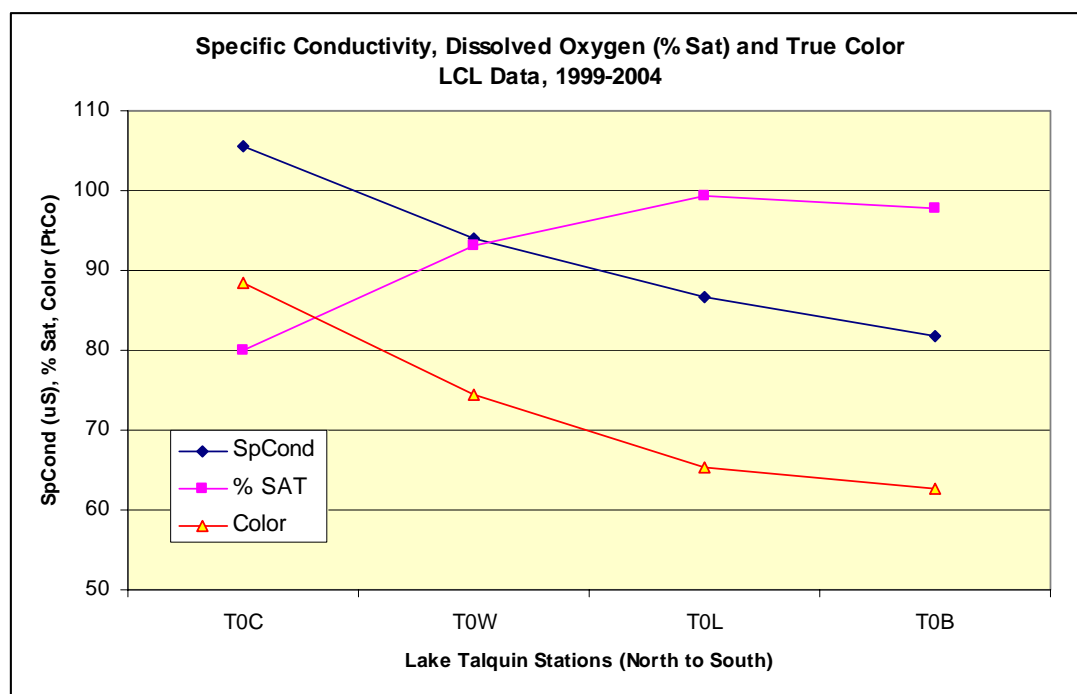
**Figure 4.2.15:** Selected water quality parameters. Lake Talquin stations arranged in the direction of flow from the Ochlockonee River, from left to right.

The LCL data from 1999 through 2004 were averaged (table 4.2.1) and depicted graphically (figures 4.2.15 – 4.2.17). The grouping of the parameters for graphical display was determined by their relative concentrations. The percent saturation of oxygen, dissolved oxygen, pH, chlorophyll, ammonia and organic nitrogen increases as the waters passes through Lake Talquin. Color and specific conductivity, turbidity, chloride, alkalinity, nitrate, ortho-phosphate, total phosphorus, total nitrogen and dissolved organic nitrogen decrease as the water passes through Lake Talquin. This follows classic the limnological model for nutrient uptake (decreasing TN, Nitrate, TIN, O-P and TP). Nutrient promoted growth (increasing chlorophyll and organic nitrogen). The effects of the growth of plants and algae, like dissolved oxygen fluctuations and increases in pH. Dilution and settling (decreasing turbidity, color, chlorides and alkalinity)

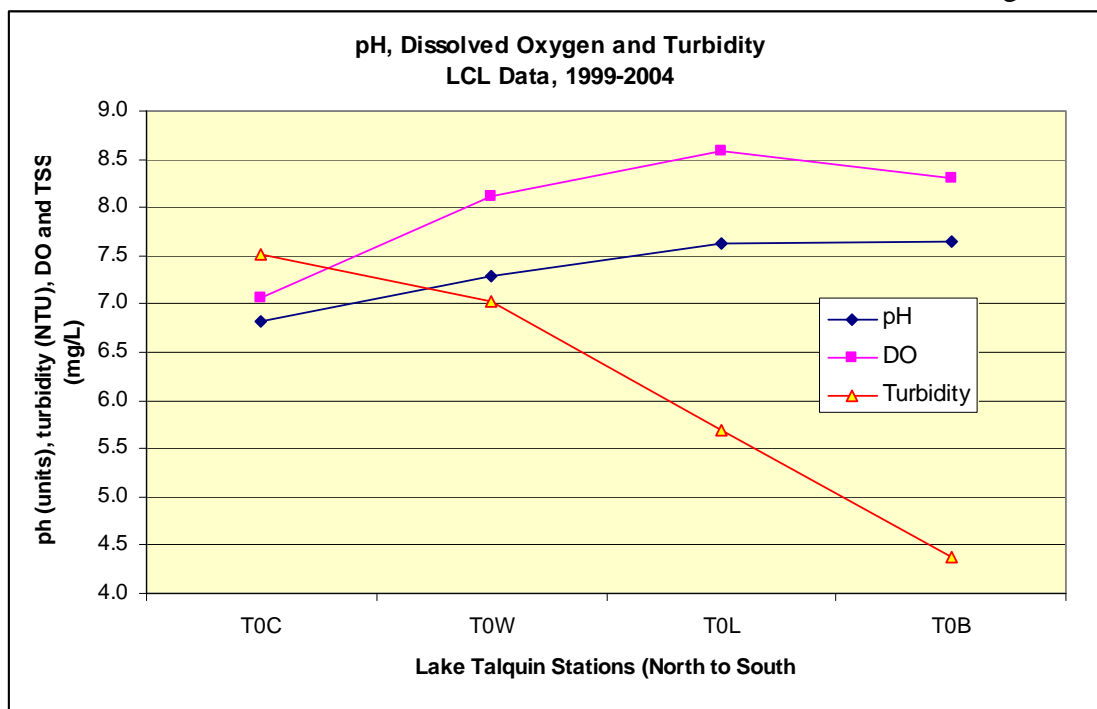
Figure 4.2.16: Selected water quality parameters. Lake Talquin stations arranged in the direction of flow from the Ochlockonee River, from left to right.

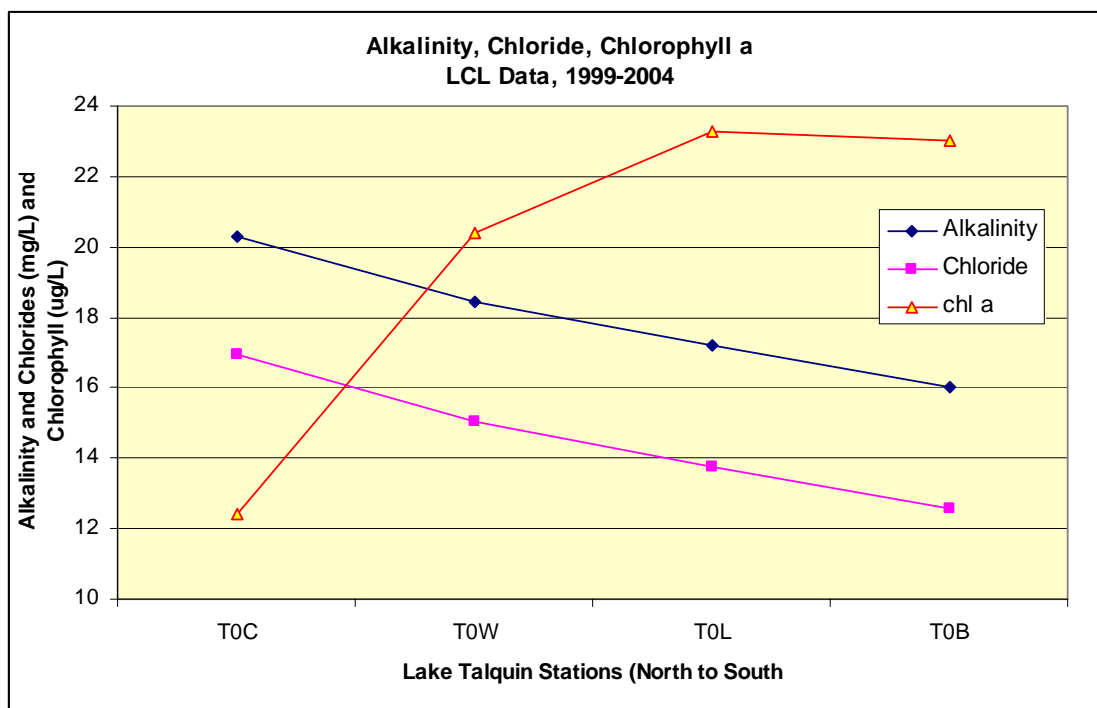
Figure 4.2.17: Selected water quality parameters (continued). Lake Talquin stations arranged in the direction of flow from the Ochlockonee River, from left to right.
